Manhole Inspection Summary

Manhole # S06II2006MH

Insp Date: **7/15/06 8:40 AM**

Location Address: **7300 WALLIS AVE**

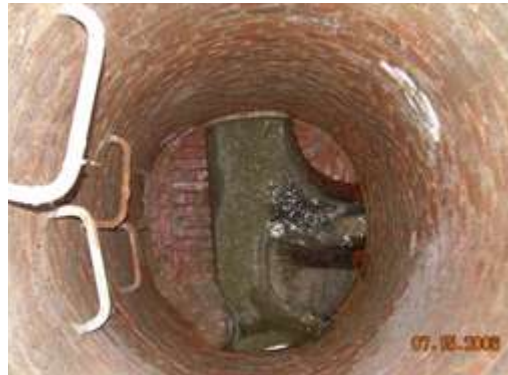
Top View

Adjustment, Corbel and Barrel infiltration.
Evidence of surcharge - Bench debris.
Corroded steps.

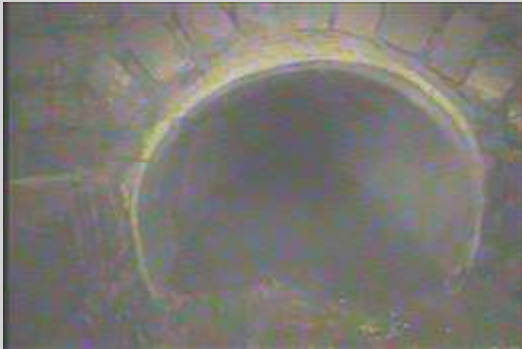
18 in. Circular Gravity Sewer Pipe Out @ 12 O'Clock

Infiltration: **Evidence** Pipe Seal Cond: **Cracked**

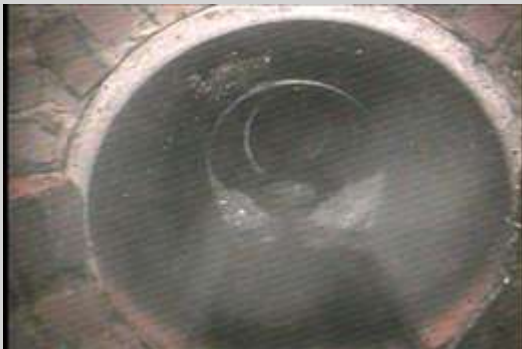
18 in. Circular Gravity Sewer Pipe In @ 3 O'Clock

Root intrusion in the first joint.

Deposits: ☐ None ☐ **Mud** ☐ Sludge ☒ **Debris** ☒ **Grease**

Infiltration: **Evidence** Pipe Seal Cond: **Unknown**

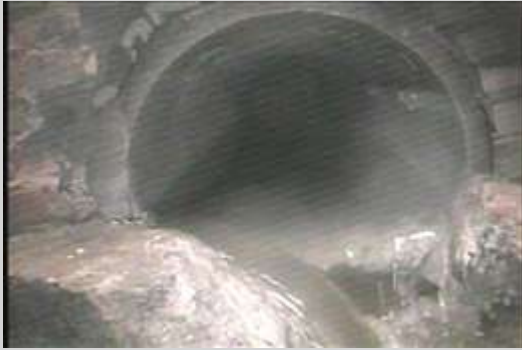
21 in. Circular Gravity Sewer

Deposits: ☐ None ☒ **Mud** ☐ Sludge ☐ Debris ☐ Grease

Infiltration: **Evidence**
